Flood Control Project Maintenance
2018 Structure Summary Report
Overall Unit and Item Ratings

DWR Sutter Maintenance Yard

Butte Slough Drainage Structure

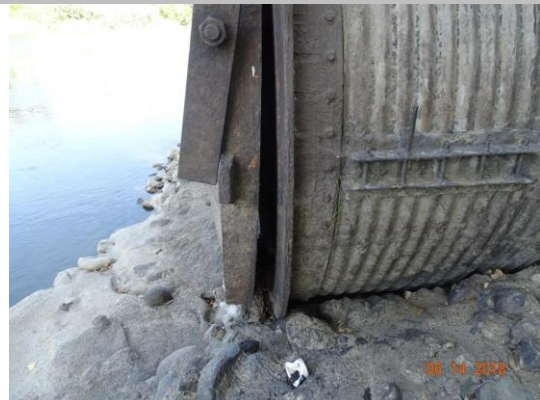
Photo 1 of 1 : ST_2018_NA0060_38_11_20180625_00014.jpg

LM Start	0.00	Rating **	M	Issue No.	11
LM End	0.00	Issue Type +	Ma	Location *	
Category	Structures & Concrete Lined Channels	GPS Latitude/Longitude			
		Start		End	
Item	Flap Gates	39.197288 °		39.197288 °	
		-121.943847 °		-121.943847 °	
DWR ID	DWR_NA0060_38_t_2012_11				
Action/Comments					
Inspector Comments: The flap gate appears to be in proper working condition. Minor debris propping the gate open.

View of the flap gate partly opened because of debris.

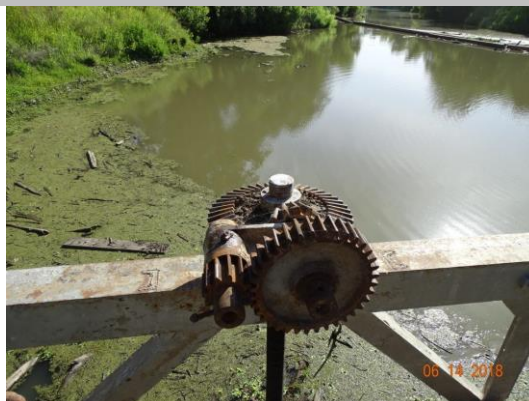
Photo 5 of 8 : ST_2018_NA0060_42_1_20180625_00016.jpg

View of the rust on the gears and railing.

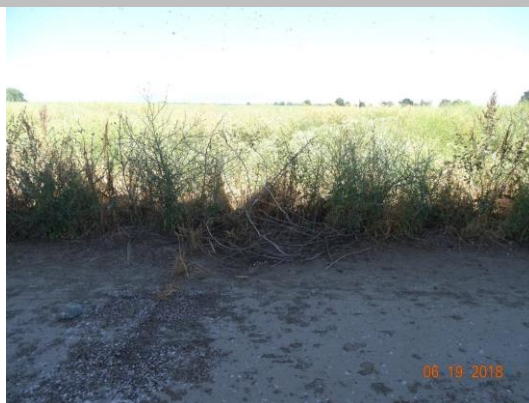
Photo 1 of 2 : ST_2018_NA0060_55_2_20180629_00029.jpg

View of the typical vegetation found in the weir looking downstream.

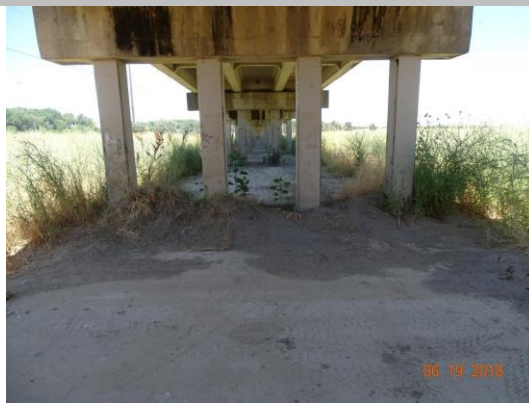
Photo 1 of 1 : ST_2018_NA0060_55_3_20180629_00031.jpg

View of the sediment builds up along piles.

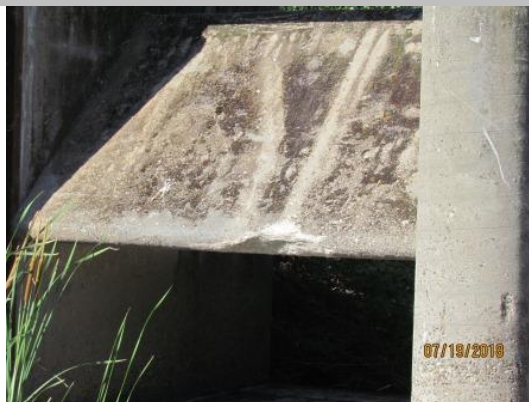
Photo 1 of 1 : ST_2018_NA0060_9_15_20180723_00030.jpg

View of one of the inlets that is showing some wear and spalling, 2018.

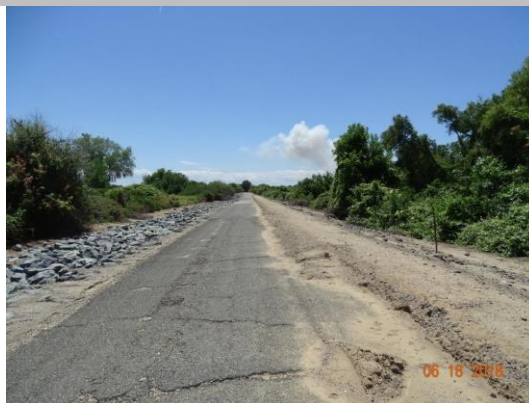
Photo 1 of 2 : ST_2018_NA0060_228_4_20180626_00011.jpg

View of the erosion on the upstream side of the weir during 2016 & 2017 high water.

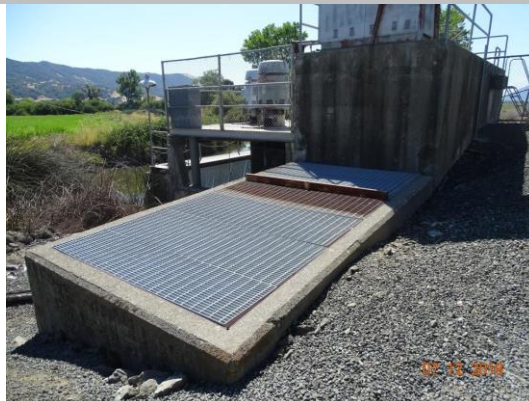
Photo 2 of 3 : ST_2018_NA0060_17_3_20180716_00020.jpg

View of adjacent structure that continues to settle. Summer 2018.

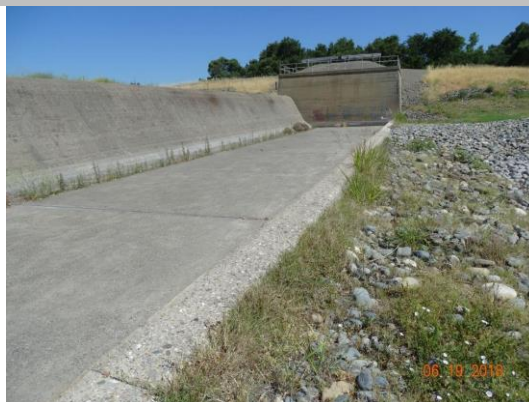
Photo 1 of 1 : ST_2018_NA0060_4_15_20180629_00033.jpg

Close view of slight wearing on concrete surface at the outfall wall.

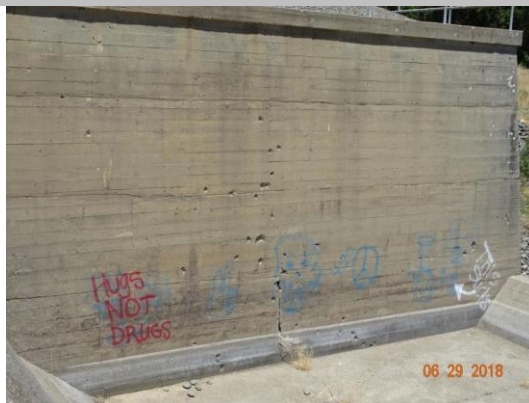
Photo 1 of 1 : ST_2018_NA0060_4_17_20180711_00034.jpg

View of a small cracks in the weir slab and part way up the left bank abutment wall.

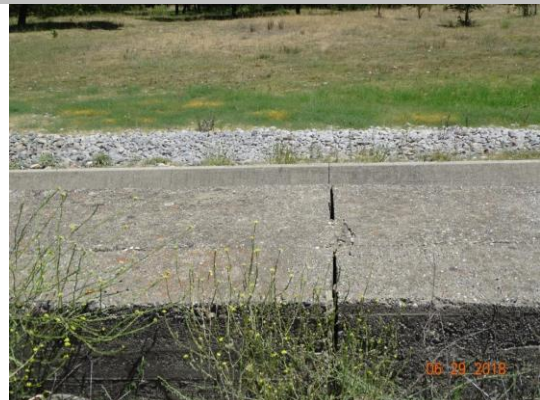
Photo 1 of 2 : ST_2018_NA0060_4_22_20180711_00035.jpg

View of the wear at one monolith joint, but not enough to compromise the integrity of the structure.

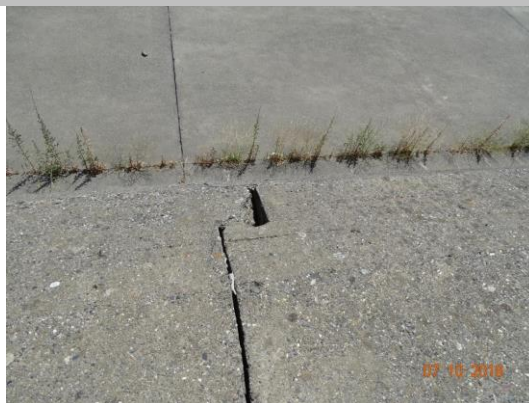
Photo 2 of 2 : ST_2018_NA0060_4_22_20180711_00036.jpg

A second view of wear at the one monolith joint, but not enough to compromise the integrity of the structure.

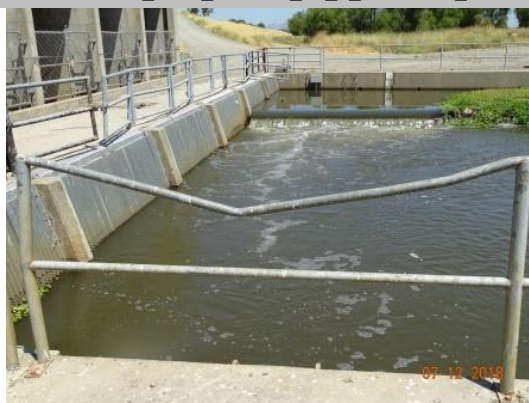
Photo 6 of 6 : ST_2018_NA0060_22_5_20180713_00043.jpg

View of bent railing at pump inlets that needs to be replaced. Photo taken July, 2018.

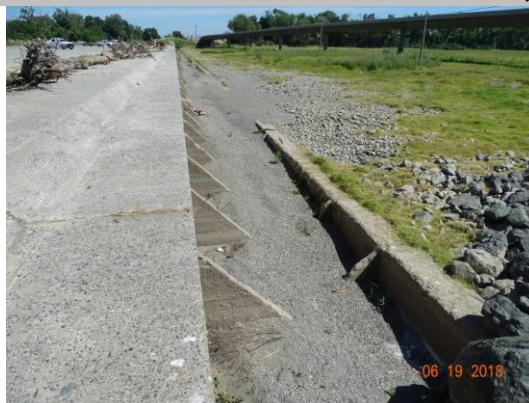
Photo 1 of 1 : ST_2018_NA0060_3_3_20180619_00048.jpg

View of sediment build-up within the stilling basin on the south side of the weir. Summer 2018.

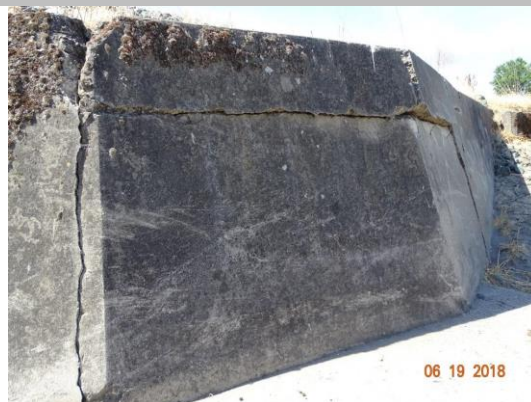
Photo 1 of 8 : ST_2018_NA0060_3_15_20180619_00038.jpg

View of cracking on the south abutment. Summer 2018.

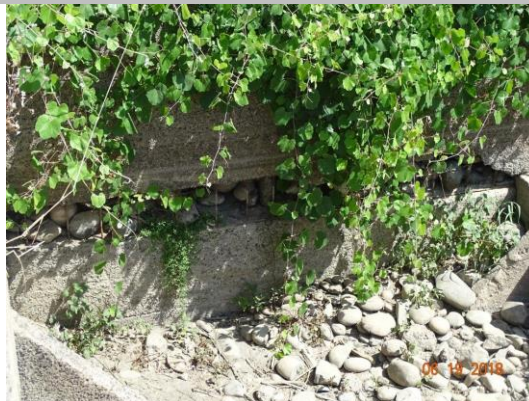
Photo 2 of 8 : ST_2018_NA0060_3_15_20180619_00039.jpg

Missing concrete and exposed rebar within the north abutment. Vegetation is beginning to grow within the abutment. Summer 2018.

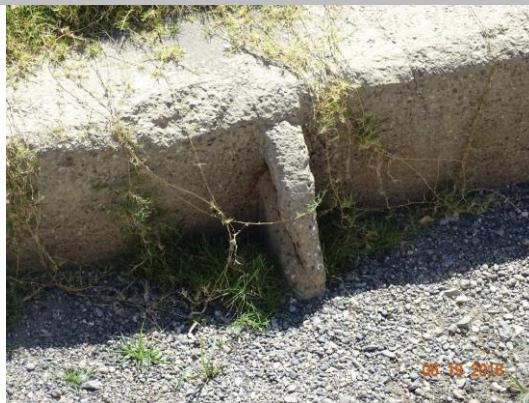
Photo 3 of 8 : ST_2018_NA0060_3_15_20180619_00041.jpg

View of deteriorating counterfort within the stilling basin. Summer 2018.

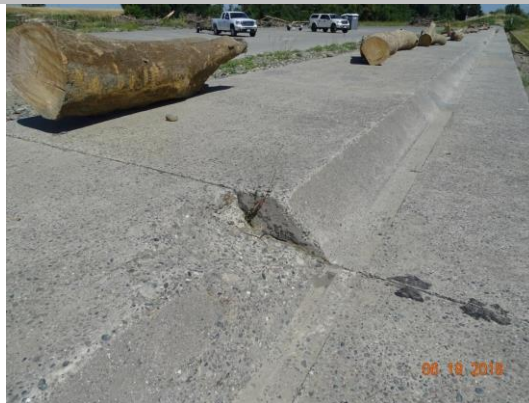
Photo 4 of 8 : ST_2018_NA0060_3_15_20180619_00042.jpg

View of concrete joint damage. It does not appear to be worse than the previous inspection, and the flow is not impeded. Summer 2018.

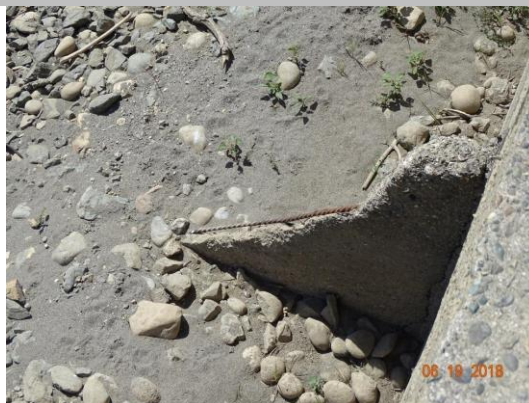
Photo 5 of 8 : ST_2018_NA0060_3_15_20180619_00043.jpg

View of exposed rebar on concrete counterfort. Summer 2018.

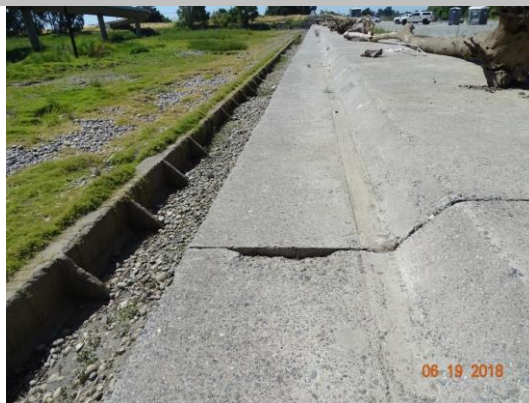
Photo 6 of 8 : ST_2018_NA0060_3_15_20180619_00044.jpg

View of additional concrete joint damage. Summer 2018.

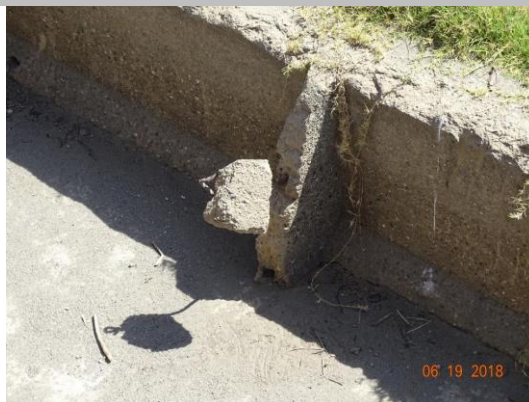
Photo 7 of 8 : ST_2018_NA0060_3_15_20180619_00045.jpg

View of damaged counterfort and exposed rebar. Summer 2018.

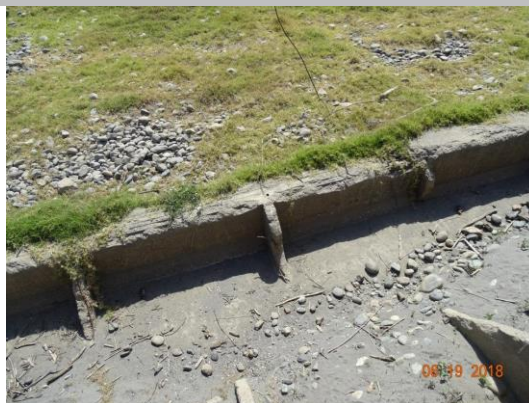
Photo 8 of 8 : ST_2018_NA0060_3_15_20180619_00046.jpg

View of exposed and bent rebar on the downstream end of the stilling basin. Summer 2018.
